Inspection Report

Test St , Test Town , NSW, Australia

CEBA Consulting services were engaged by xxxxxxxxxx to ascertain the likely cause of an ongoing water intrusion into the garaging during rain fall events to the property know as "xxxxxxxxxxxxxxxxxxxx", and to supply this report with such findings.

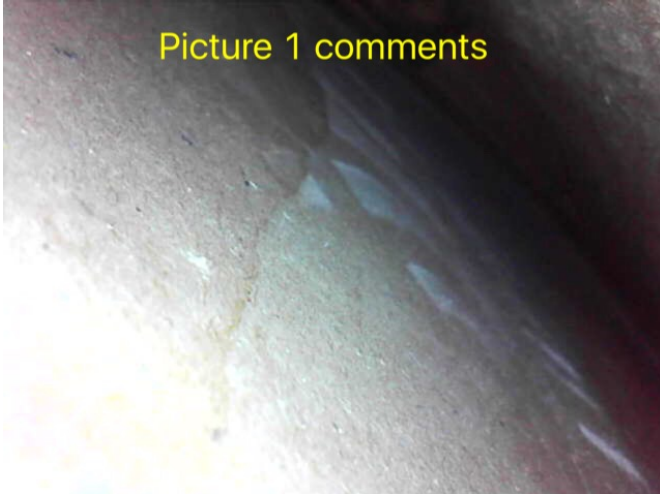
Picture 1 comments

Watermark noted to the ceiling void section behind load-bearing steel beam supporting the wall above and the concrete suspended Deck

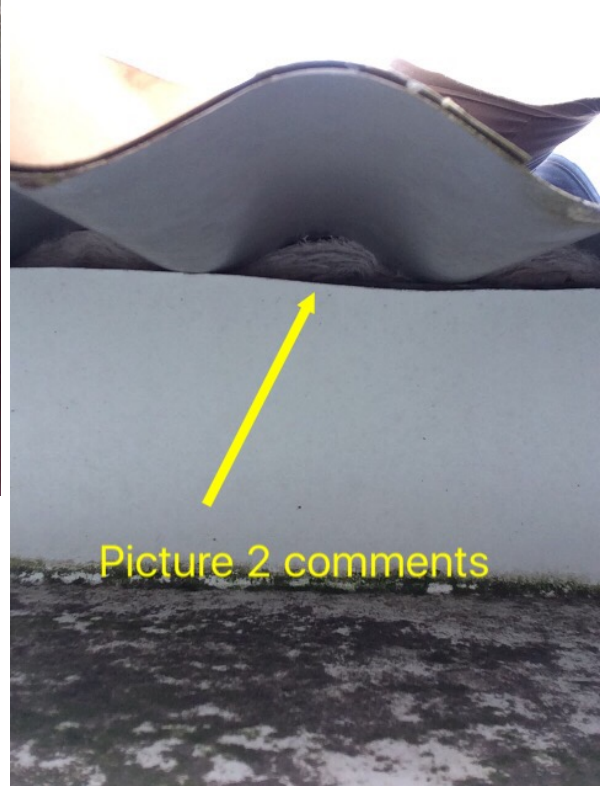
Picture 2 comments

The purpose of this is, it is possible that water capillary action may occur at this point allowing water ingress into the roof cavity. Once in the roof cavity it is likely to track down the wall cavity.

In this particular case the wall cavity is seated on a load bearing steel beam located mid way through the garage in close proximity to the water marking noted in picture 1

It is recommended that an additional flashing be installed.

The flashing should return down into the box gutter by a min of 30mm for the full length of the gutter be made fully water tight with silicone and riveted in position.

The same flashing should also extend up the roof on the underside of the existing sheeting a recommended min of 450mm finished with a return 10 mm fold along all edges. An additional batten should also be installed at this point.

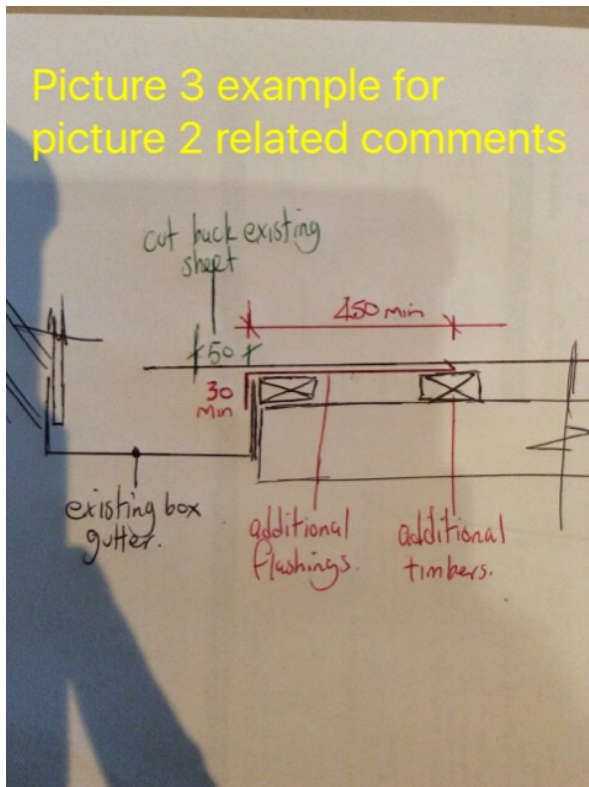
Picture 3 comments

EXAMPLE ONLY for picture 2 related comments. Not to scale.

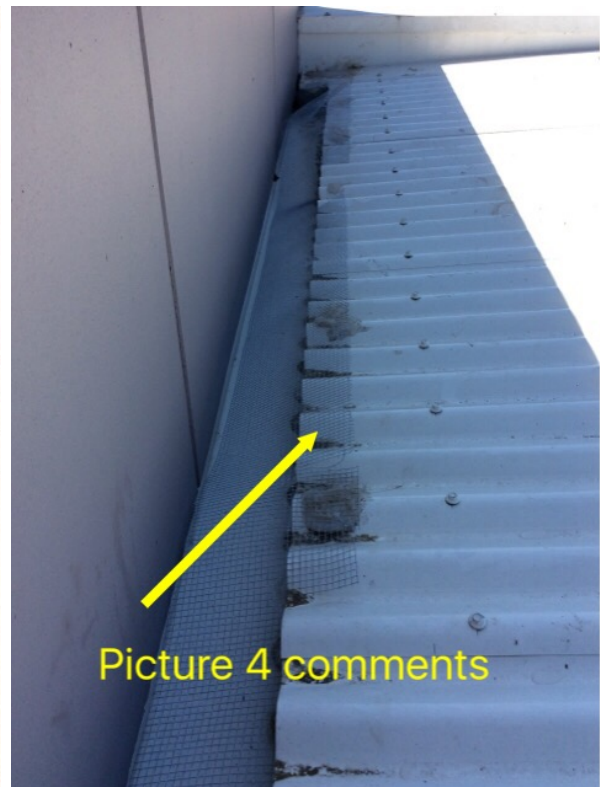
Picture 4 comments

The current excessive sheet overhang May create a wind tunnelling effect aiding water capillary action. Sheet Roof overhangs are defective if they overhang by more than 65mm or less than 50mm.

It may be recommended that the current sheet length be reduced to a 50mm overhang with the pan of the sheet being slightly folded/struck down forming a drip point.

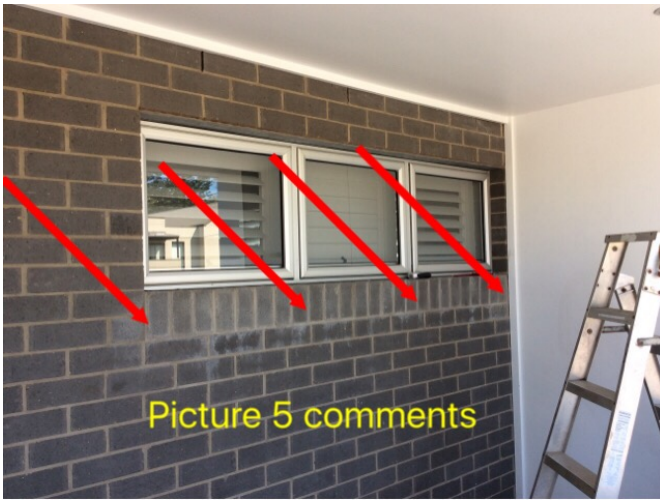
Picture 5 comments

It was noted during inspection that the window sill flashing was installed correctly, however with no relief/discharge points.

It is recommended that a series of weep holes be installed at the base of the window sill flashing, to allow cavity moisture to externally discharge. This may also reduce efflorescence forming at the base of the brick sill soldier course.
